TEST REPORT # **T1007-1**

SAMPLE DESCRIPTION: SUPER SSR 11 IN. BIOFIBER BLOCK WALL ASSEMBLY. See page 3 for full description.

TESTING REQUESTED: **Testing to the mandatory requirements of the following criteria:
ASTM E119-14, Standard Test Methods for Fire Tests of Building Construction and Materials, and CAN/ULC S101-07, Standard Methods of Fire Endurance Tests of Building Construction and Materials**

TESTED RATING: 68-minute Fire Resistance

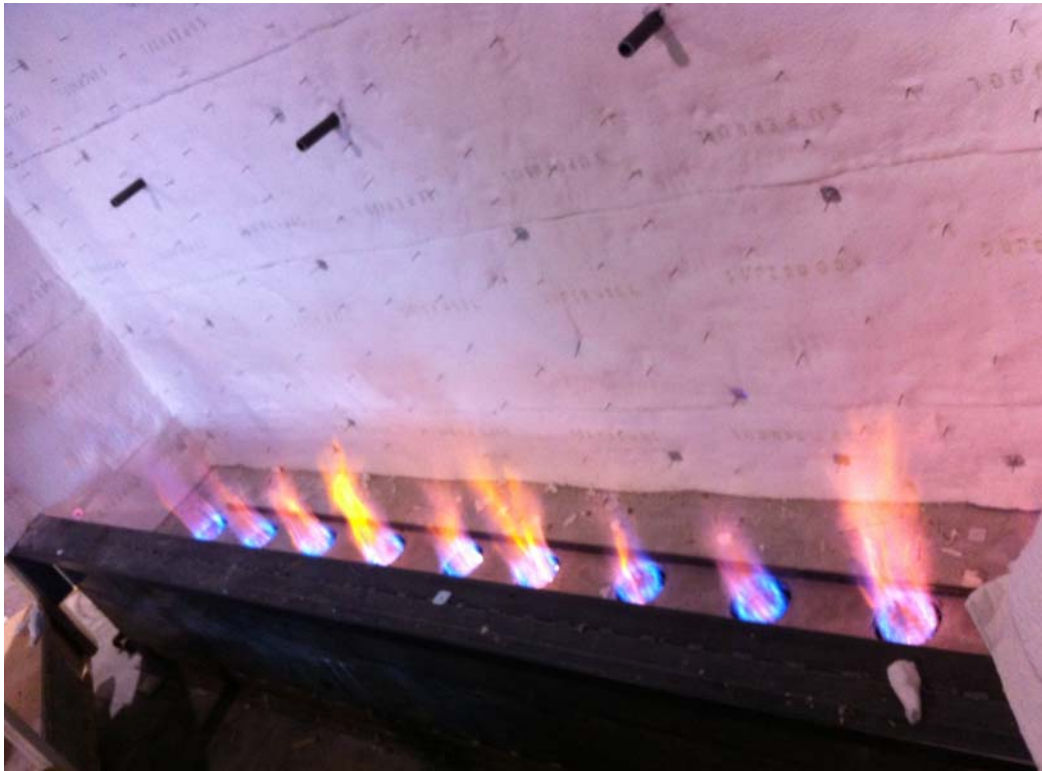
Figure 1: Burners Fired in the Furnace

The furnace used in the test is a full-scale fire burning apparatus with interior dimensions of 13 ft. in height, 13 ft. in width, and 3 ft. in depth.

Temperatures within the furnace were monitored using nine thermocouples. The temperatures are controlled by adjusting fuel to the furnace burners to conform to the time/temperature curve specified by the test standards. Temperature measurements are recorded by a Keithley 2750 data acquisition unit (ID# DMM1) which passes the readings to a computer for graphical display and storage.

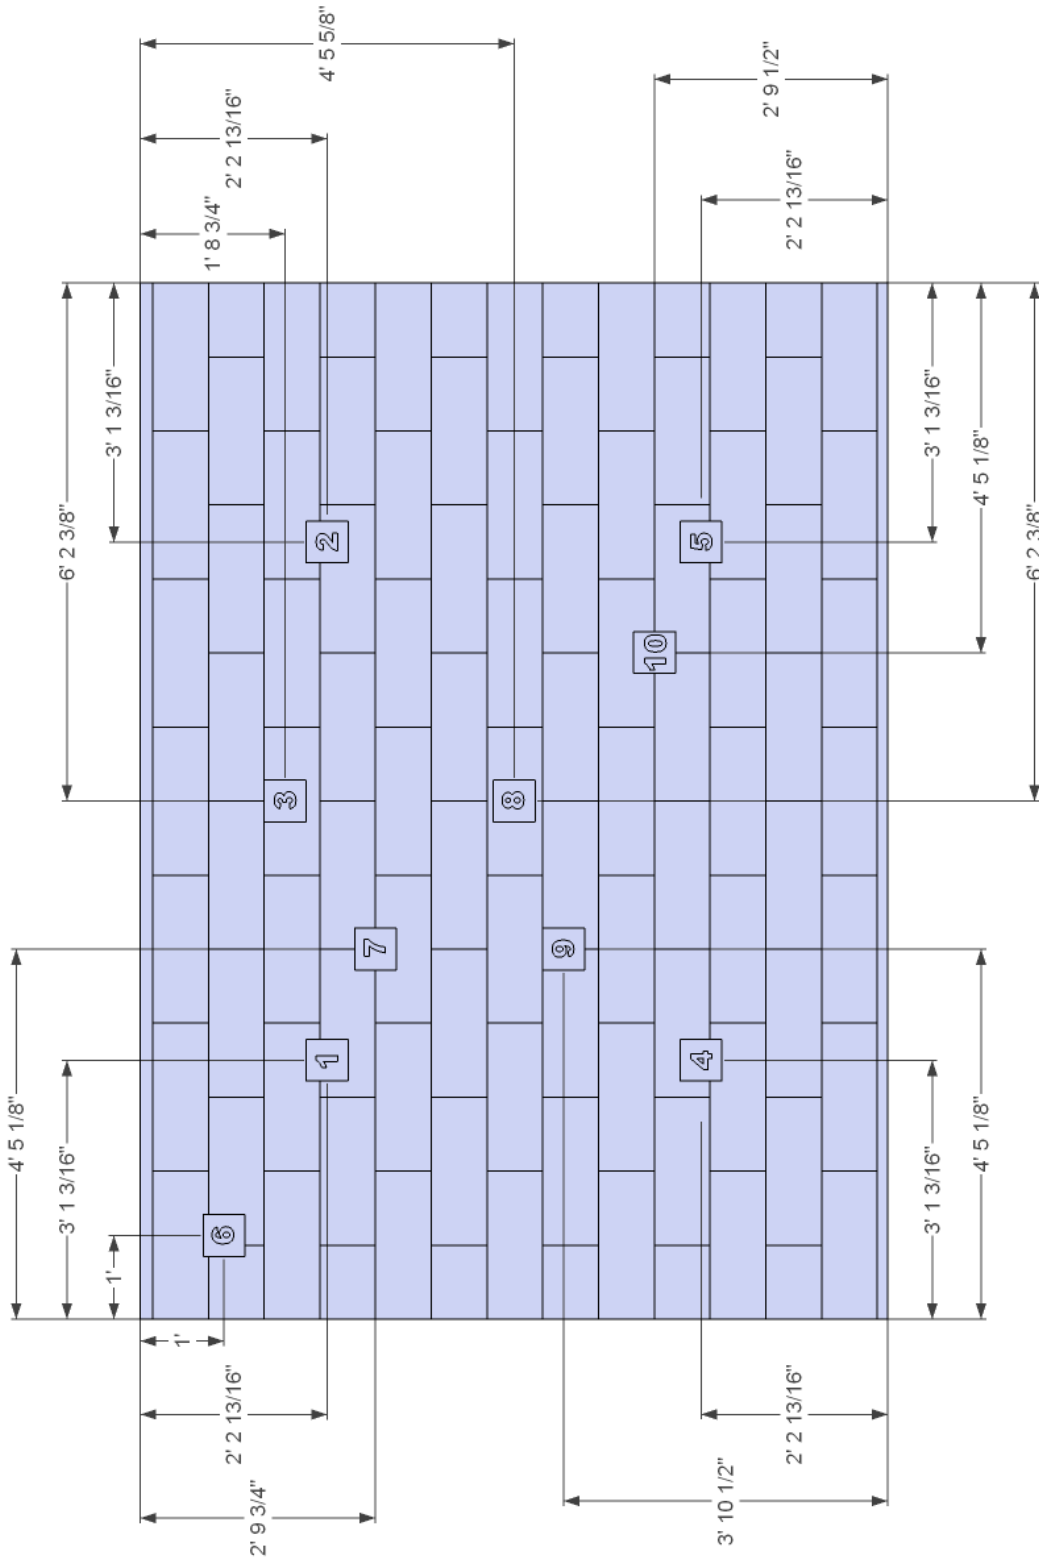
Figure 4: Unexposed Face Thermocouple Locations

Unexposed wall surface temperatures were monitored by thermocouples (TCs) placed at a minimum of nine locations. Five of these were symmetrically disposed, one to be at the center of the assembly, and four at the center of each quarter section. Detailed locations are shown in Figure 4 in Appendix A. The temperatures were recorded continuously for the duration of the test. The temperature rise data are provided graphically in Figure 5 and 6 in Appendix A.

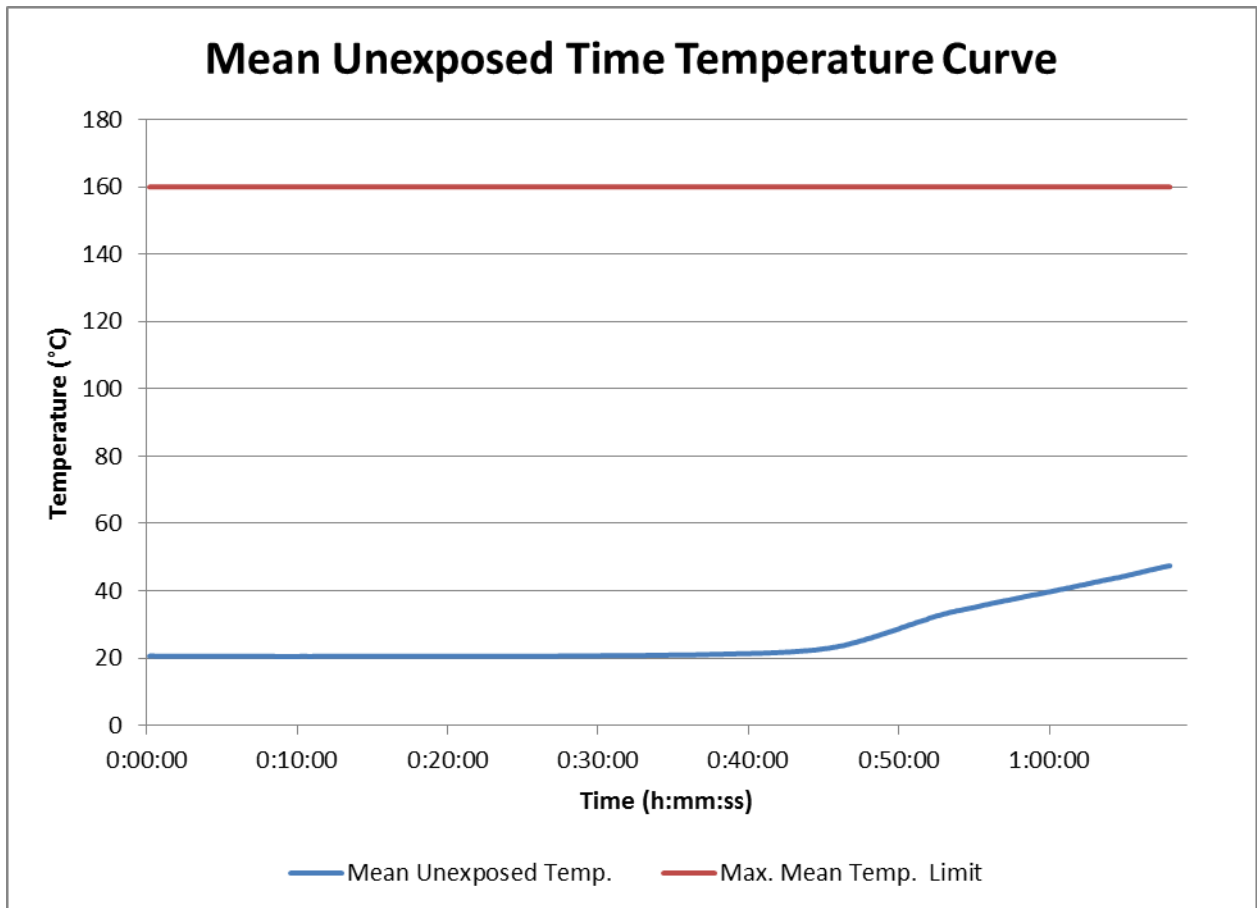
Figure 6: Mean Unexposed Time Temperature Curve

During the fire endurance test the average temperature measured by the unexposed thermocouples reached a maximum of 27°C above initial, and the maximum temperature reached by an individual point was 63°C above initial. The maximum allowable average temperature rise is 140°C above the initial average temperature, and the maximum allowable temperature at an individual point is 180°C above its initial temperature. The wall assembly met the unexposed temperature rise requirements of the test standard.

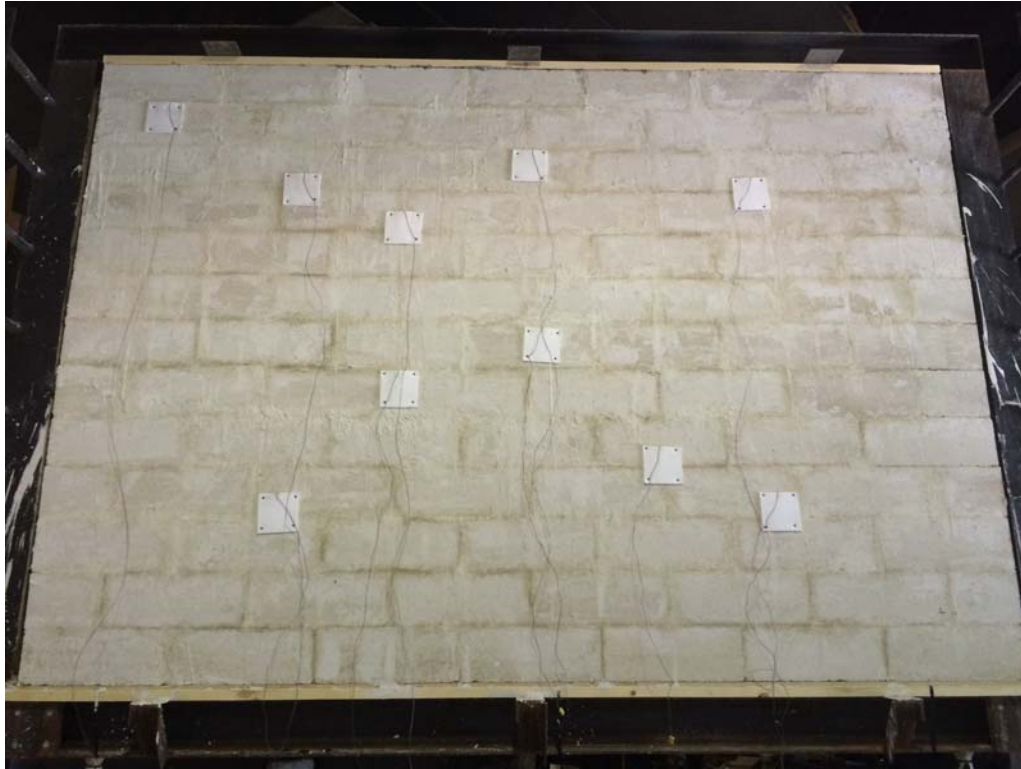
Figure 7: Unexposed side prior to the fire test.

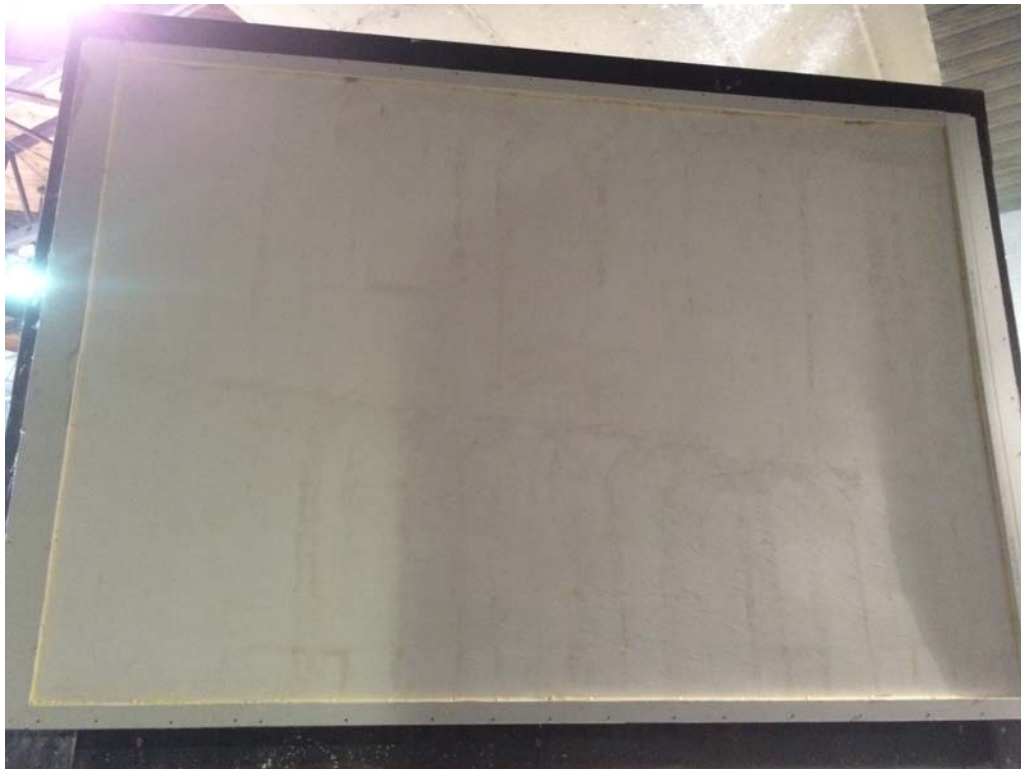
Figure 8: Exposed side prior to the fire test.

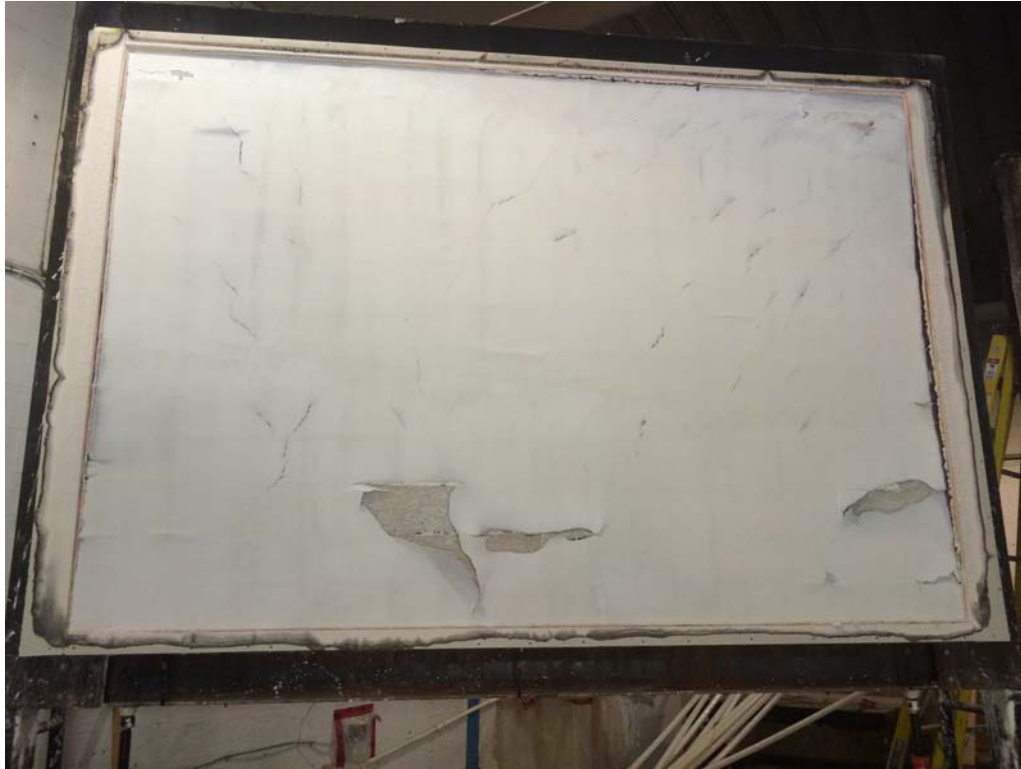
Figure 9: Exposed side at termination of fire exposure.

Test Time (min)	Unexposed	Exposed
8:48		Cracks have formed in the plaster. Intermittent flaming at the cracks.
9:33		The plaster is beginning to peel away at the cracks.
13:23		Aggressive flaming at 3 locations approx. 2 ft. from the bottom.
16:42		Cracks in the plaster are forming at mid-height.
18:00		Crack at the top right corner is flaming.
28:25	Venting through a block joint near the top center.	
33:20	Venting from the joint at the top right corner.	
40:00		Small cracks forming across the surface.
52:42		1 ft. by 1 ft. section of plaster has fallen from the wall approx. 3 ft. from the bottom.
68:00	Test discontinued.	No change.

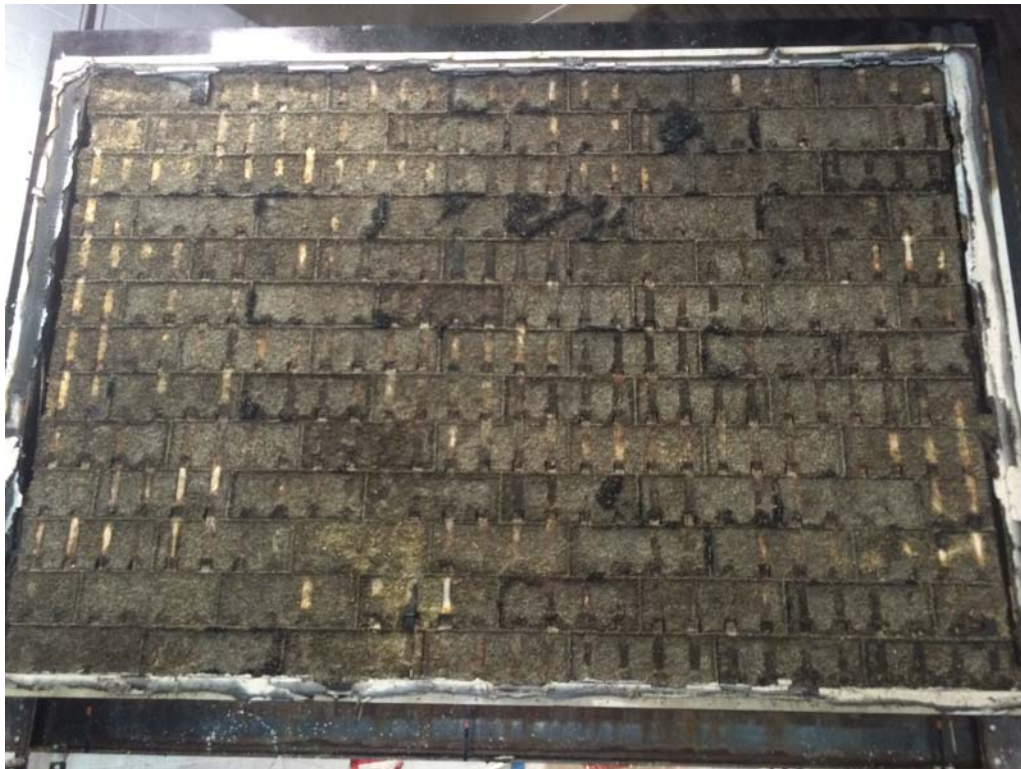
Figure 10: Exposed side after the hose stream test.

Immediately after the fire test, a hose stream test was conducted for 67 seconds. The wall assembly successfully met the conditions of acceptance for the hose stream test: no through openings were developed that would allow a projection of water from the stream beyond the unexposed face during the time of the hose stream test.

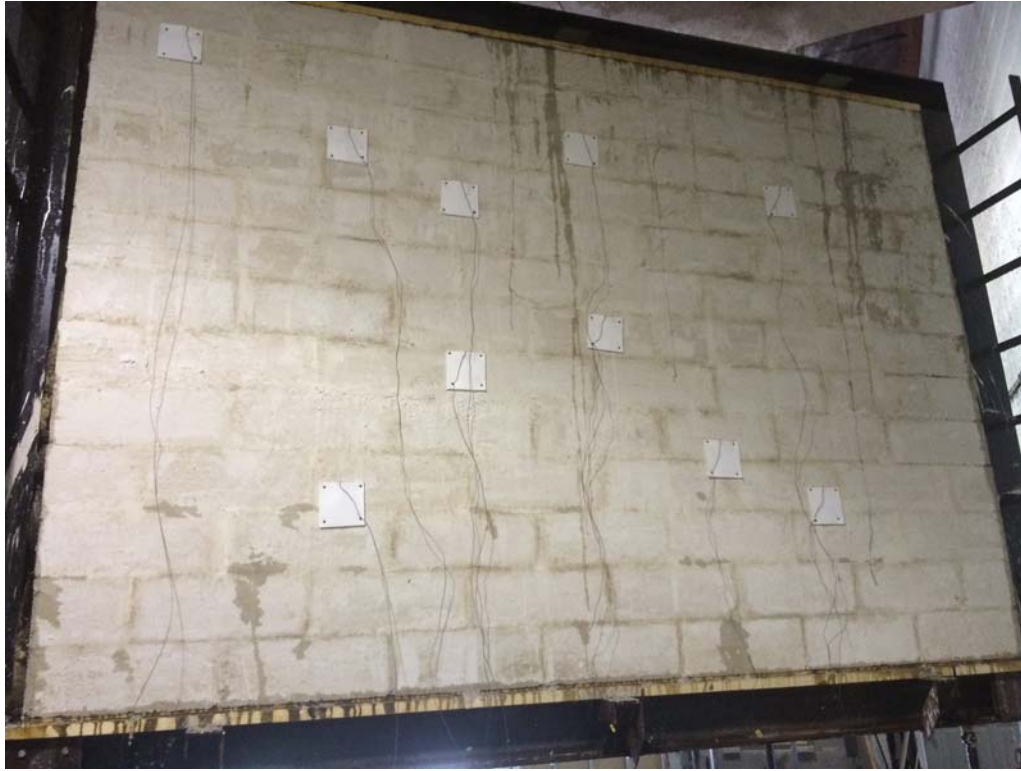
Figure 11: Unexposed side after the hose stream test.

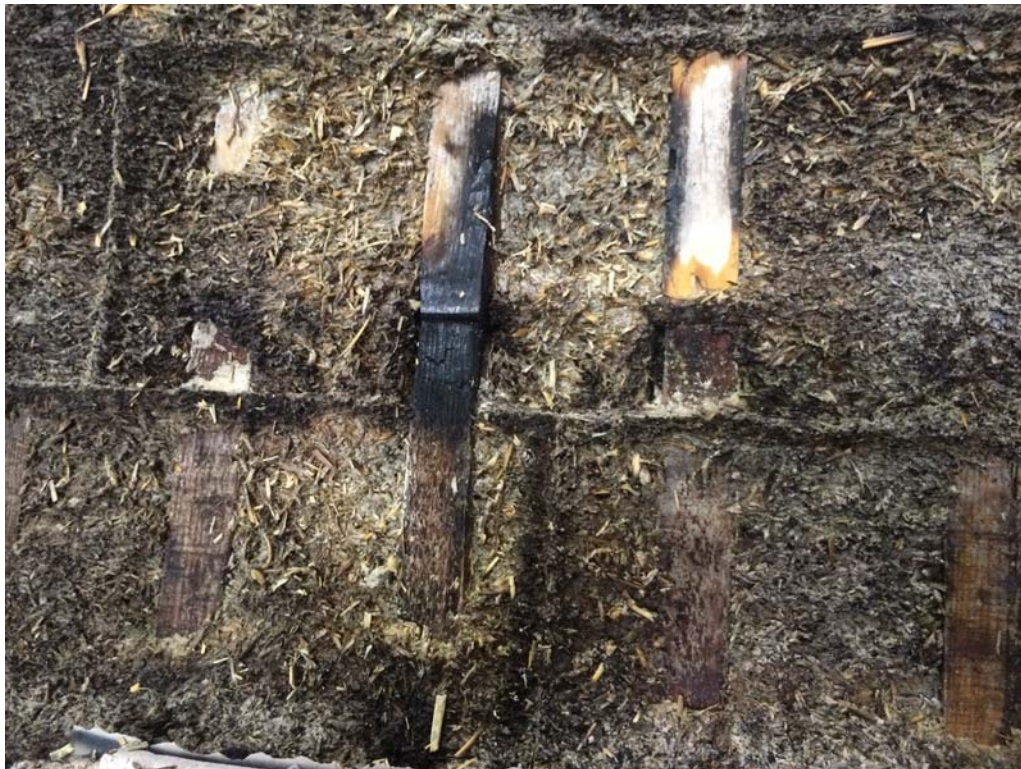
Figure 12: Exposed side after hose stream test at the center lower portion of wall near the area where the plaster had fallen off.
